Re: American Gypsum-Albuquerque; Multi-Sector General Permit; SIC 3275; NPDES Compliance Evaluation Inspection; NPDES # NMR053164; December 20, 2018

NPDES Compliance Inspection Report

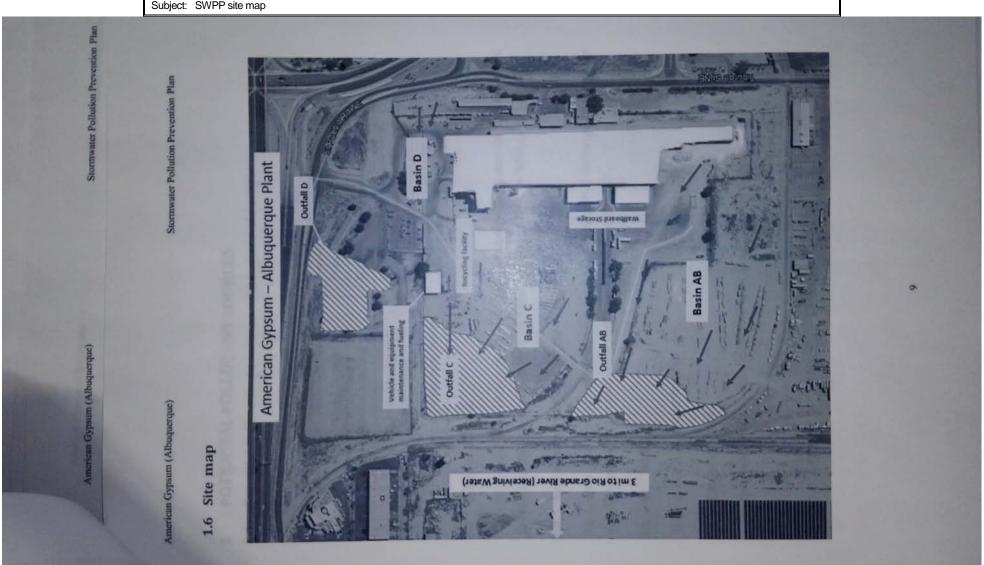
NMED/SWQB Official Photograph Log Photo #1				
Photographer: Jennifer Foote	Date: 12/20/18	Time: 10:31am		
City/County: Albuquerque/ Bernalillo County	State: New Mexico			
Location: American Gypsum- Albuquerque				
Cubicate CM/DD site man

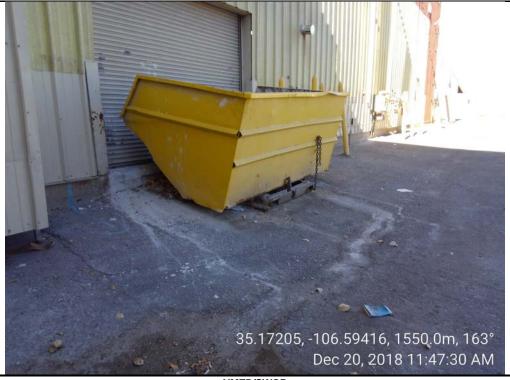
NMED/SWQB Official Photograph Lo Photo # 2	g		
Photographer: Jennifer Foote	Date: 12/20/18	Time: 11:47am		
City/County: Albuquerque/ Bernalillo C	county	State: New Mexico		
Location: American Gypsum- Albuquerque				
Subject: dumpster with liquid stains adjacent to storm drain

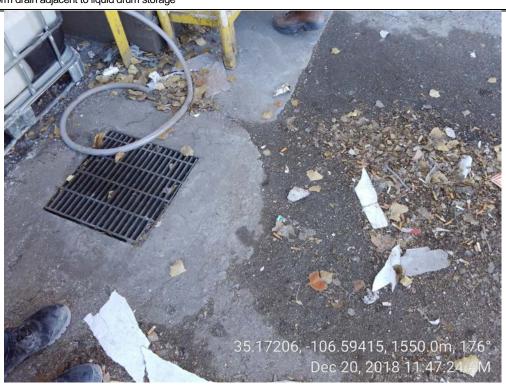
NMED/SWQB Official Photograph Log Photo # 3				
Photographer: Jennifer Foote	Date: 12/20/18	Time: 11:47am		
City/County: Albuquerque/Bernalillo C	City/County: Albuquerque/ Bernalillo County State: New Mexico			
Location: American Gypsum- Albuquerque				
Subject: locked storm drain adjacent to liquid drum storage

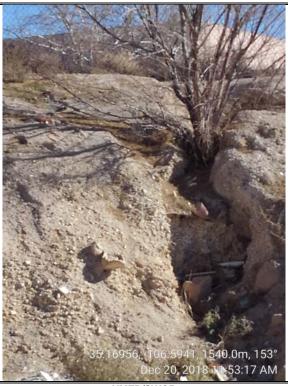
NMED/SWQB Official Photograph Lo Photo #4	og		
Photographer: Jennifer Foote	Date: 12/20/18	Time: 11:53 am		
City/County: Albuquerque/Bernalillo C	ounty	State: New Mexico		
Location: American Gypsum- Albuquerque				
Subject: erosion from run-on on east side of facility

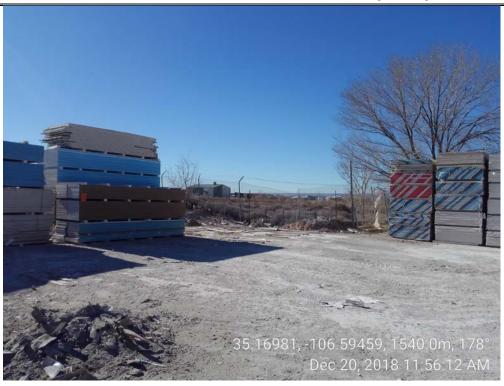
260 20 20 10 10 10 10 10 10 10 10 10 10 10 10 10			
NMED/SWQB			
Official Photograph Log			
	Photo # 5		
Photographer: Jennifer Foote	Date: 12/20/18	Time: 11:56 am	
City/County: Albuquerque/ Bernalillo County		State: New Mexico	
Location: American Gypsum- Albuquerque			
Subject: drainage swale to west with windblown trash. However, drains to basin AB and does not discharge from larger site limits

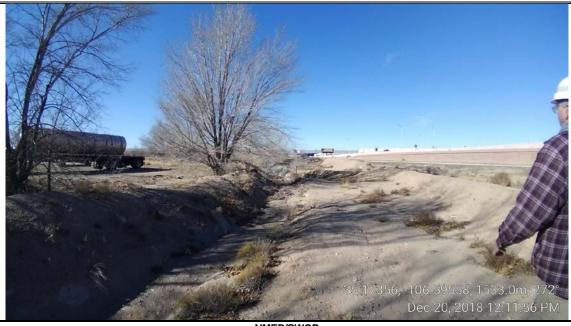
NMED/SWQB Official Photograph Log Photo # 6			
Photographer: Jennifer Foote	Date: 12/20/18	Time: 12:11 pm	
City/County: Albuquerque/Bernalillo County		State: New Mexico	
Location: American Gypsum- Albuque	rque		
Subject: "outfall D" channel looking we	st towards outfall break in berm

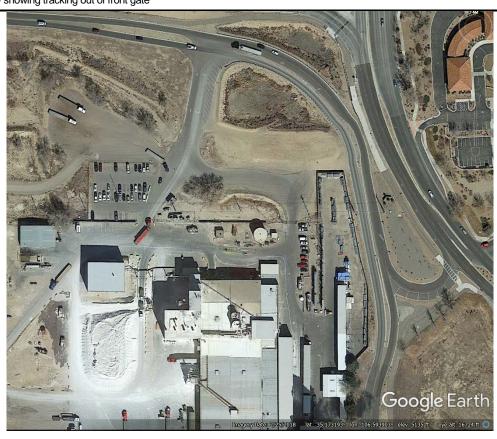
SWPPP Implementation	n
Waste, Garbage and Floatable Debris	(e.g., Keep all dumpster lids closed when not in use. For dumpsters and roll off boxes that do not have lids and could leak, ensure that discharges have a control (Minimize the potential for waste, garbage and floatable debris to be discharged by keeping exposed areas free of such materials, or by intercepting them before they are discharged) Windblown and floatable debris were present (photo 2, 3, 4,5).
Evidence of non- storm water discharges	No non-stormwater discharges were observed on the day of the inspection. There were signs of wet material recycle leakage from a door and dumpster adjacent to a storm drain. (photo 2,3)
Dust Generation and Vehicle Tracking of Industrial Materials	(minimize generation of dust and off-site tracking of raw, final, or waste materials) Google earth shows tracking from the facility (photo 7), however, that area drains to retention ponds.

NMED/SWQB Official Photograph Le Photo # 7	
Photographer: Google Earth	Date: 2/25/18	Time: n/a
City/County: Albuquerque/ Bernalillo County		State: New Mexico
Location: American Gypsum- Albuque	que	
Subject: Aerial view showing tracking of	out of front gate
